ANALYSING ARCHITECTURE AS A BASIS FOR RESTORATION DECISIONS

THE ZUIDERKERKSTOREN IN AMSTERDAM

PIETER VLAARDINGERBROEK

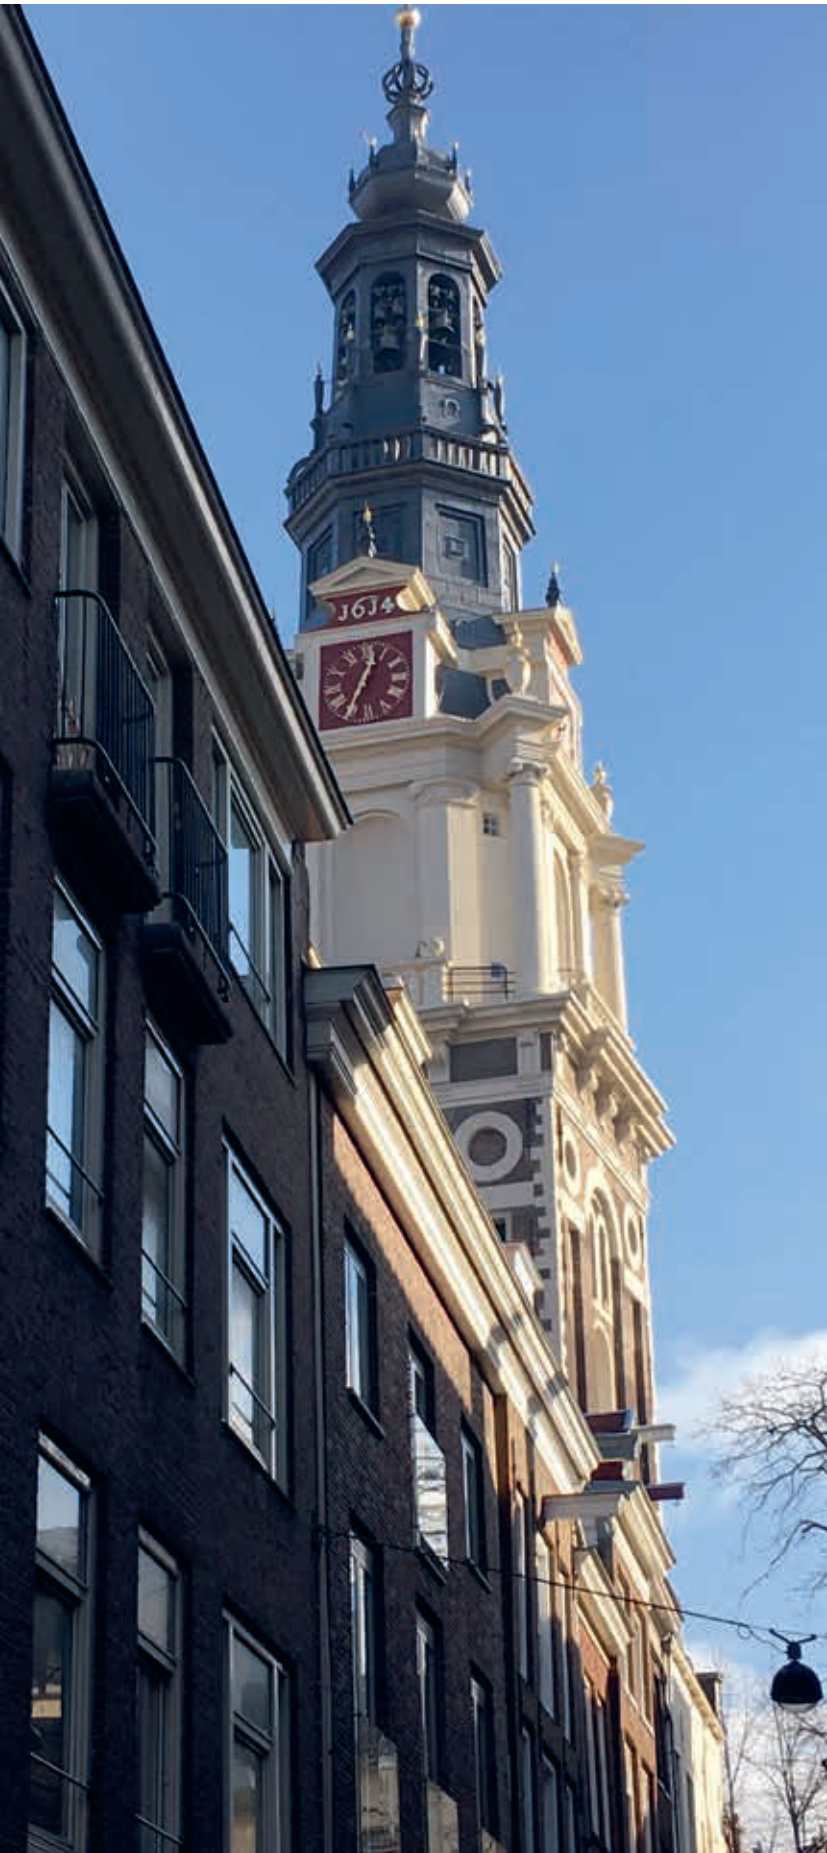
◀ 1. The Zuiderkerkstoren in the colour scheme of 1978 (photo Han van Gool, Municipality of Amsterdam, Monuments and Archaeology)

In 1978 the colour scheme of the tower was studied by the head of the Amsterdam's Heritage Office, Henk Zantkuijl, who thought he detected a light-coloured finishing coat on the tower. However, laboratory research later revealed that the coating observed by Zantkuijl was of lead oxide rather than a coat of paint. Nevertheless, the tower was painted in accordance with the Public Works Department's 'white tower plan', whereby the lead was painted in a light Bentheimer sandstone colour, resulting in a different colour scheme.²⁹ The sandstone octagon, which had aged considerably over the centuries, was painted in a light colour, so that it resembled the original sandstone again. The red dials were retained, as were the blue vases. The lead of the spire was painted in the same light colour, creating a contrast with the parts covered with slate.

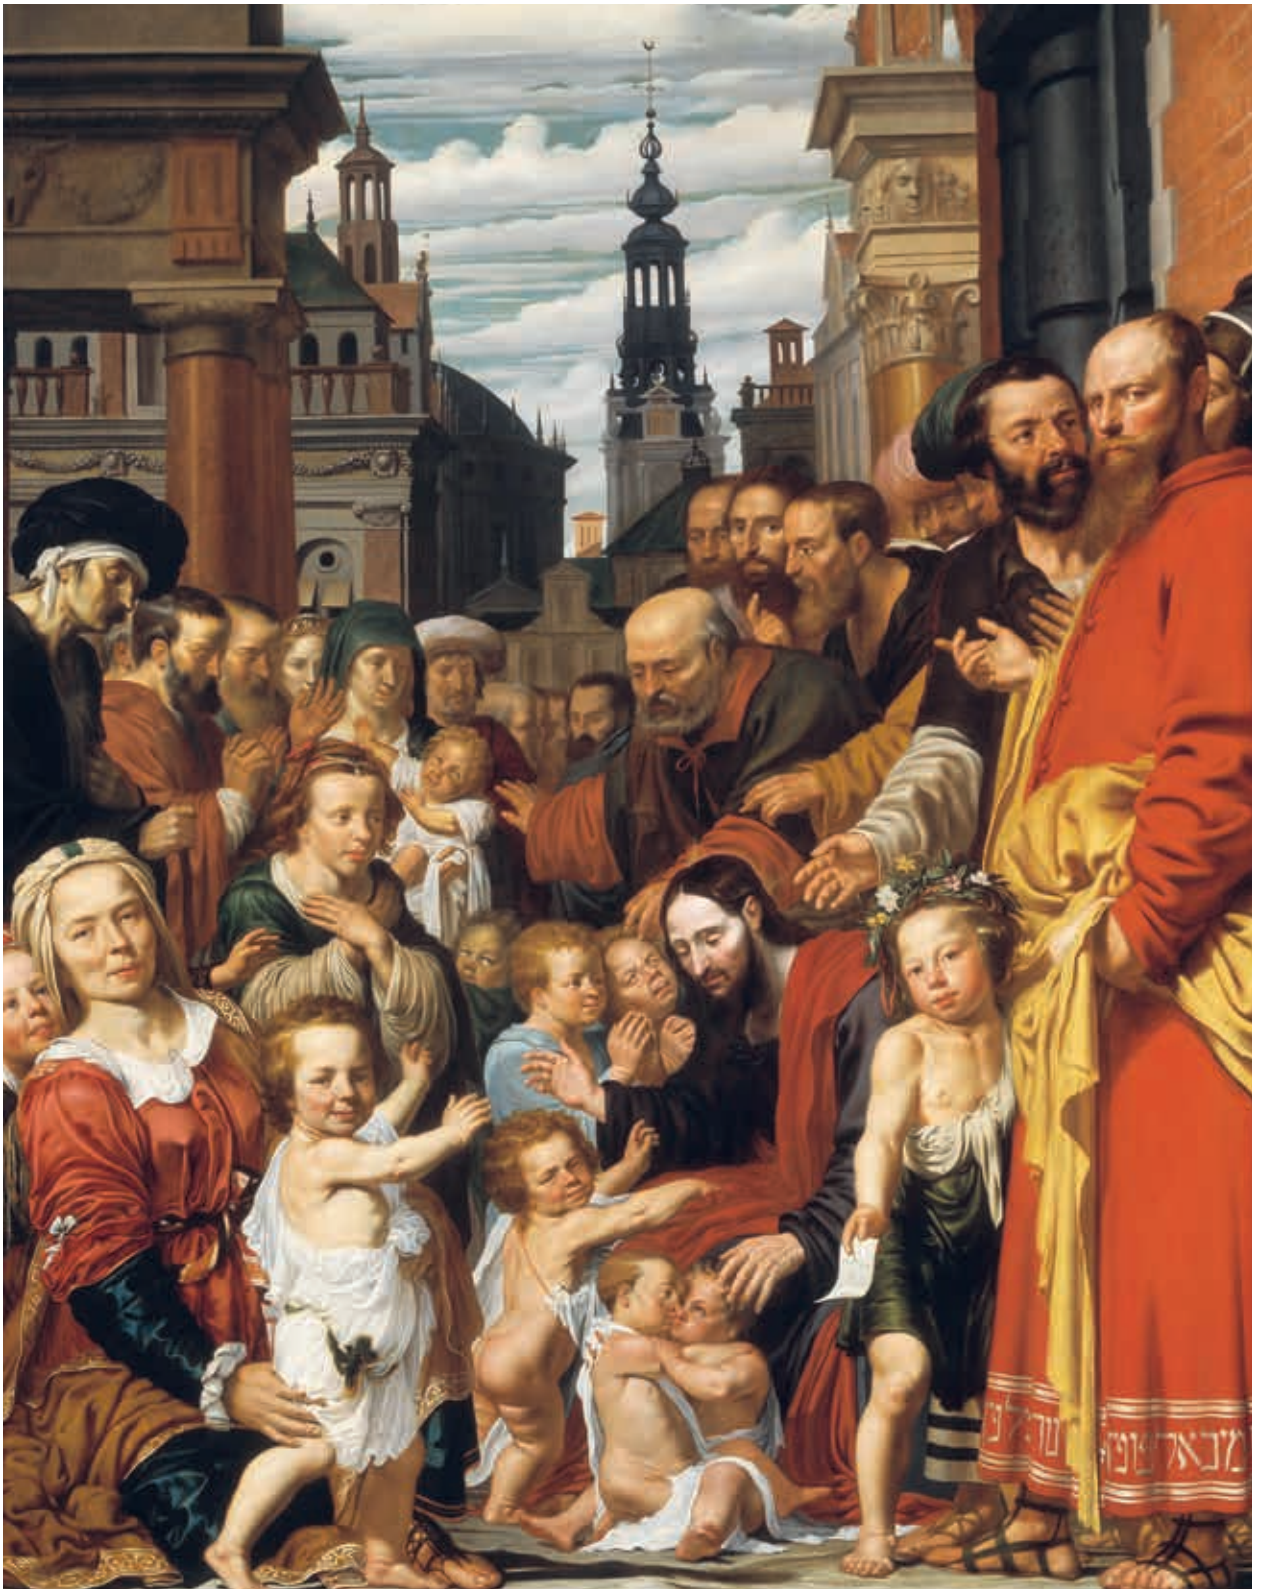
5. T. Brouwer, view and cross-section of the Zuiderkerkstoren (1870), as depicted in W.N. Rose (ed.), *Afbeeldingen van oude bestaande gebouwen, uitgegeven door de Maatschappij tot Bevordering der Bouwkunst*, Haarlem/The Hague 1852-1875 (City Archives Amsterdam, editing author)

If the design of the tower is considered from the point of view of its internal structure, the tower can be described as a brick and stone shell around two belfries, the upper one of which partially protrudes above the shell. This protruding part is covered with lead and presents on the outside as a spire (fig. 5).¹³ The carillon hangs from the upper belfry, while the heavy swinging bells hang from the lower one.

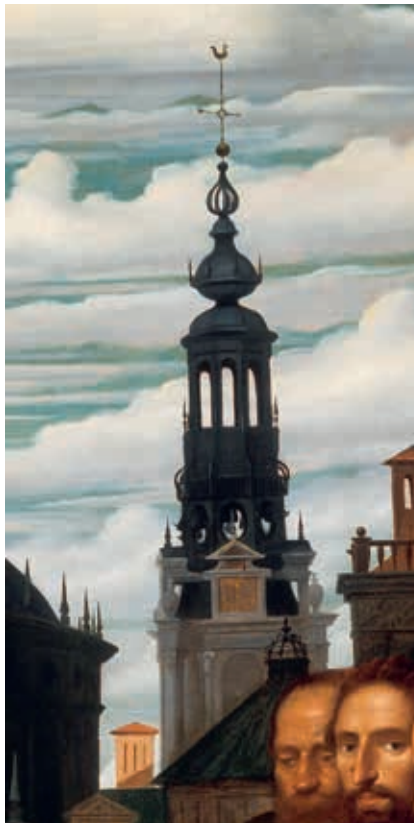
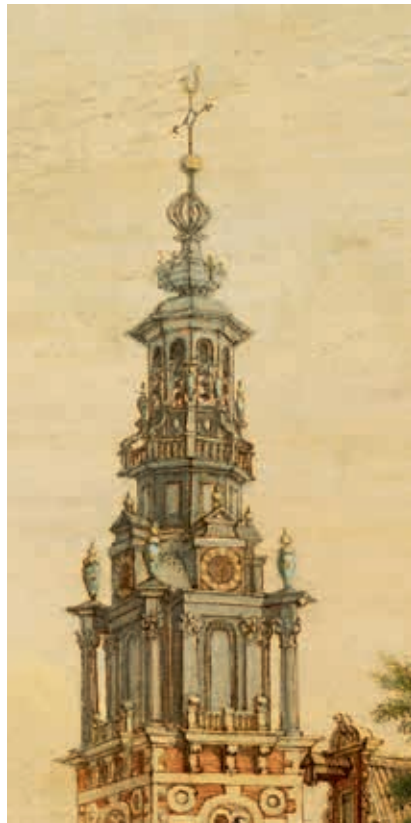
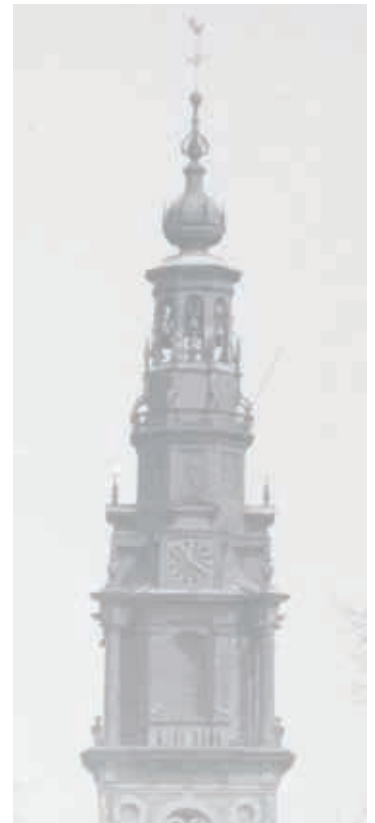
7. The interrelationship of parts in the brick and stone sections of the tower. The blue-coloured areas indicate the air that used to flow behind the dials (adaptation of fig. 4 by the author)

Despite the fact that a formal description of the tower often leads to a threefold division, the question can be asked whether this is correct. Isn't a twofold division, as perceived by Zantkuijl, more accurate? In answering this question, it is essential to look at where the base of the tower ends, and the spire begins. In my opinion, the stone octagon is not part of the spire, but part of the tower. An analysis of the tower design suggests a separation between base and spire above the level of the stone octagon with clocks. The series of semi-circular recesses on both parts provide the connection between the stone part of the tower and the brick base. The stone octagon itself (minus the columns) consists of alternating narrow and wide bays, occupied by semi-circular niches set in flat niches. These flat niches are as the same size as the semi-circular niches in the brick base. The narrow niches of the serlianas in the brick base are the same width as the Ionic columns. In light of these dimensions, it seems feasible to conclude that the stone octagon is the crowning glory of the brick base and that the design of the base is very similar to this. The dimensions suggest that the stone octagon has a strong affinity with the brick base, justifying the proposition that these two parts form a whole (fig. 7).

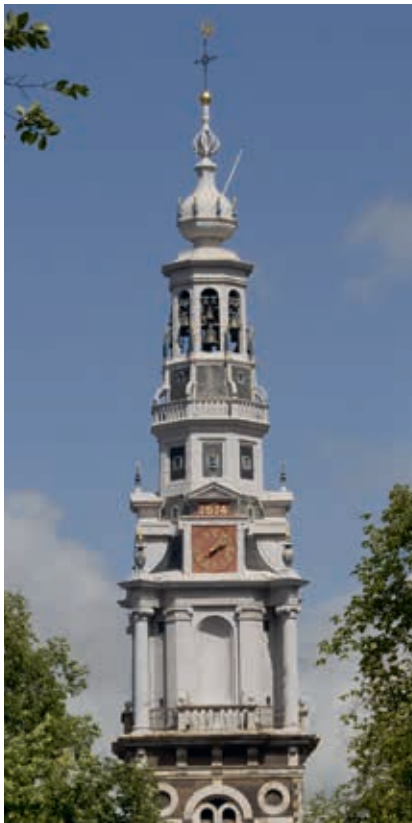
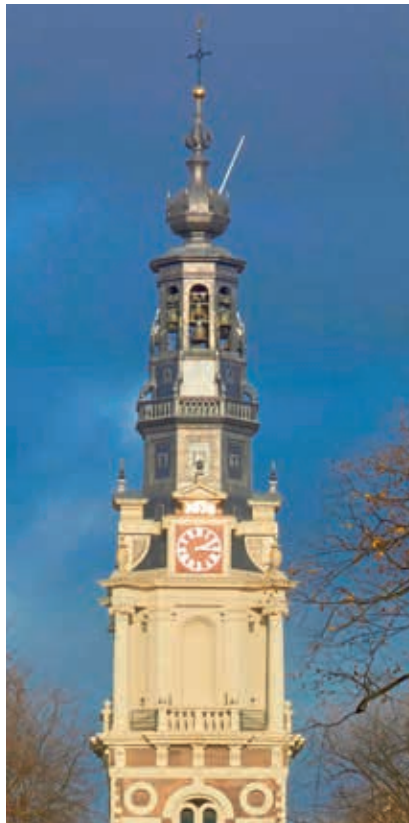
8. The three colour phases of the Zuiderkerkstoren up until the last restoration and the current colour scheme. The original colour scheme as depicted in the painting by Werner van der Valckert from 1620 (detail from fig. 6); the darkened phase as seen in a painting by Jan de Beijer from 1758 (Amsterdam Museum) and in a photo from c. 1870 (photo A. Jager, City Archive of Amsterdam); the Zantkuijl phase from 2008 (photo Han van Gool, City of Amsterdam, Monuments and Archaeology) and the current situation (photo Paul Nieuwenhuizen, City of Amsterdam, Monuments and Archaeology)

What did change over the centuries, however, was the colour scheme of the Zuiderkerkstoren. The ageing of materials and in particular the darkening of the sandstone meant that by the late seventeenth century the colours of the church tower must already have looked different compared with immediately after construction. Roughly speaking, there have been three colour phases up until the last restoration: the original tower (1614); the weathered tower (c. 1660-1978); the painted tower with the light top (1978-2017) (fig. 8).
