THE RESTORATIONS OF THE RIETVELD SCHRÖDERHUIS

A REFLECTION

MARIE-THÉRÈSE VAN THOOR

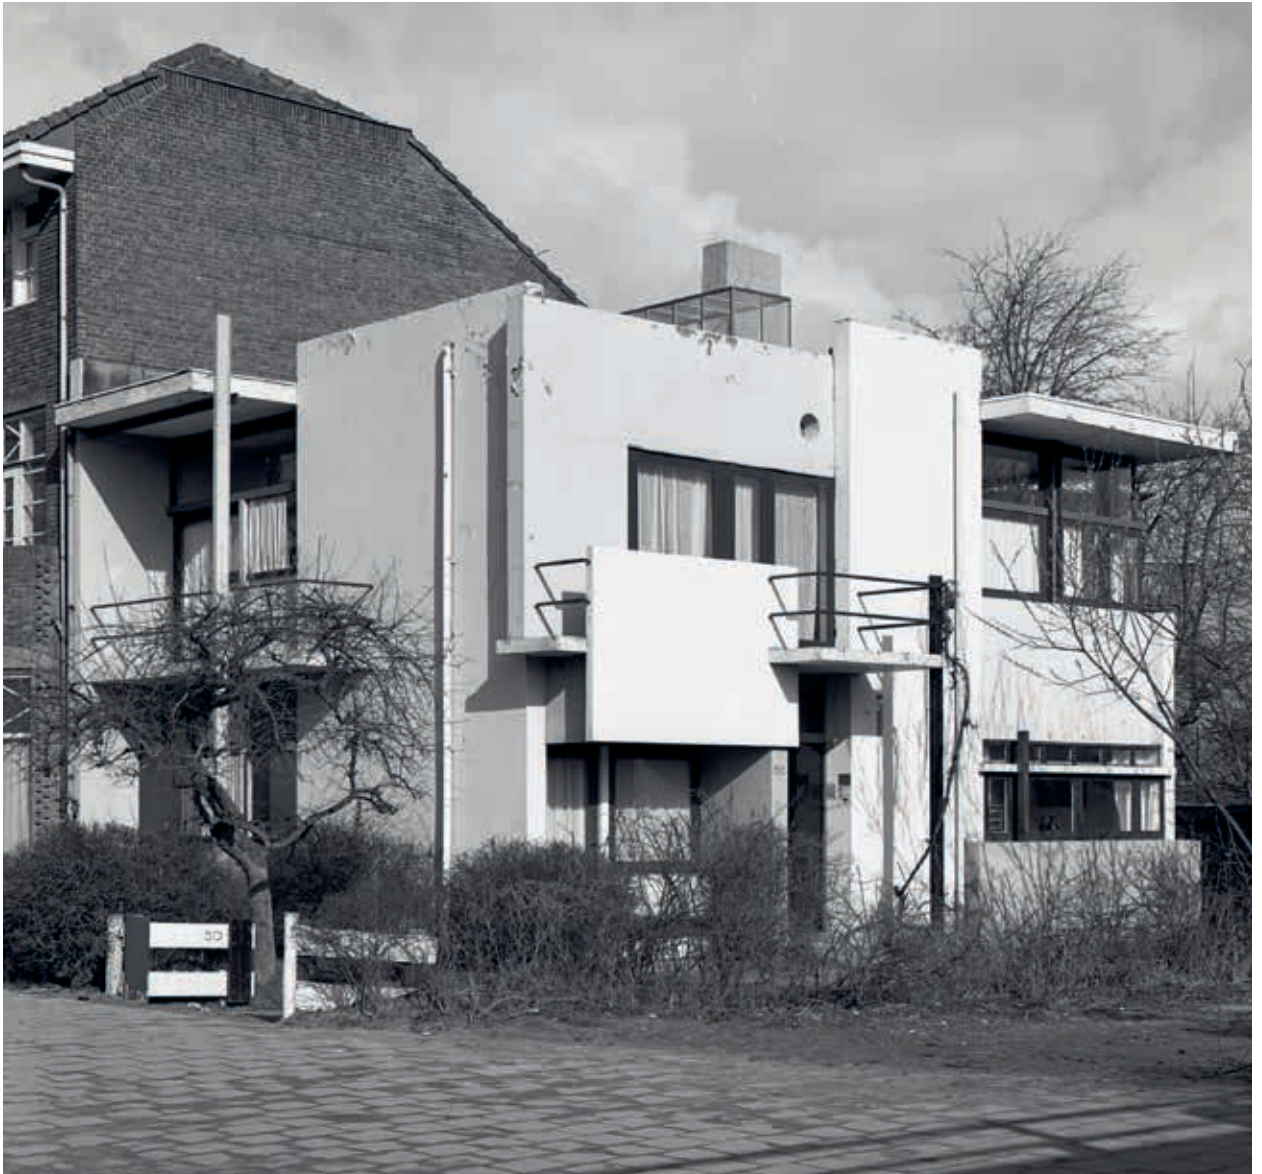
2. At the beginning of the 1970s the poor state of repair of the Rietveld Schröder House was clearly visible (Het Utrechts Archive)

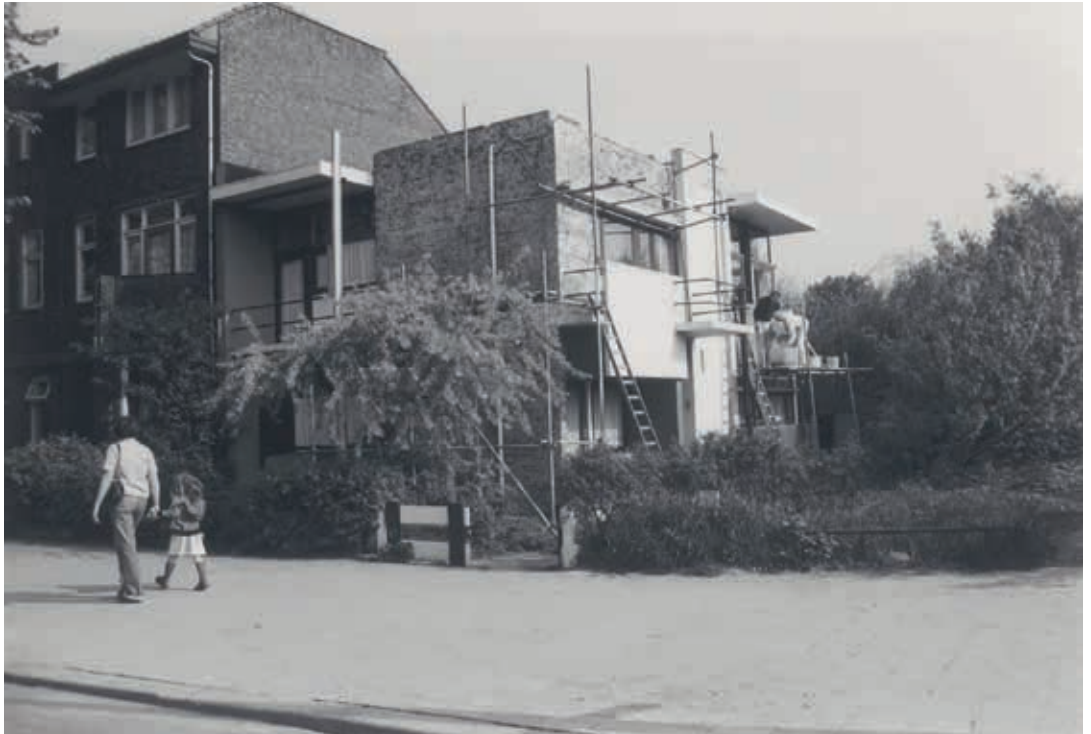
5. In 1979 the Rietveld Schröder House was once again scaffolded after the reappearance of the problems with the plasterwork. Large areas of render were first chipped away, after which a new coat was applied (Bertus Mulder archive)

Recent research has shown that the problems with the plasterwork soon returned. The paintwork was again exhibiting cracks, the new coat of render had failed to adhere, and there were dark patches in the coat of paint. In October 1975, therefore, the new plasterwork was partially removed and redone. But the hairline cracks returned once more. Eventually, in late 1978, Mulder and the client decided to strip the problematical wall back to the brickwork. That substrate proved to be homogeneous and of reasonably good quality. The earlier repairs with synthetic mortar had held up well. Mulder's report on this (1980) contained a notable sentence: 'The other plasterwork that had remained in place during the restoration had to be removed as well in order to obtain a single homogeneous layer of render and to avoid bonding problems between old and new work.'²¹ This statement would appear to imply that Mulder stripped all the walls and then had them replastered and repainted, which is what the photographs also appear to show (figs. 5 and 6). But if we examine the photographs more closely, we can also see areas with the render still intact, such as the wall below the ground-floor window overlooking Prins Hendriklaan. Mulder recently recalled that plaster remained in place on the wall beneath the kitchen window and on parts of the white surfaces of the front entrance wall and the rear wall (fig. 7)²²

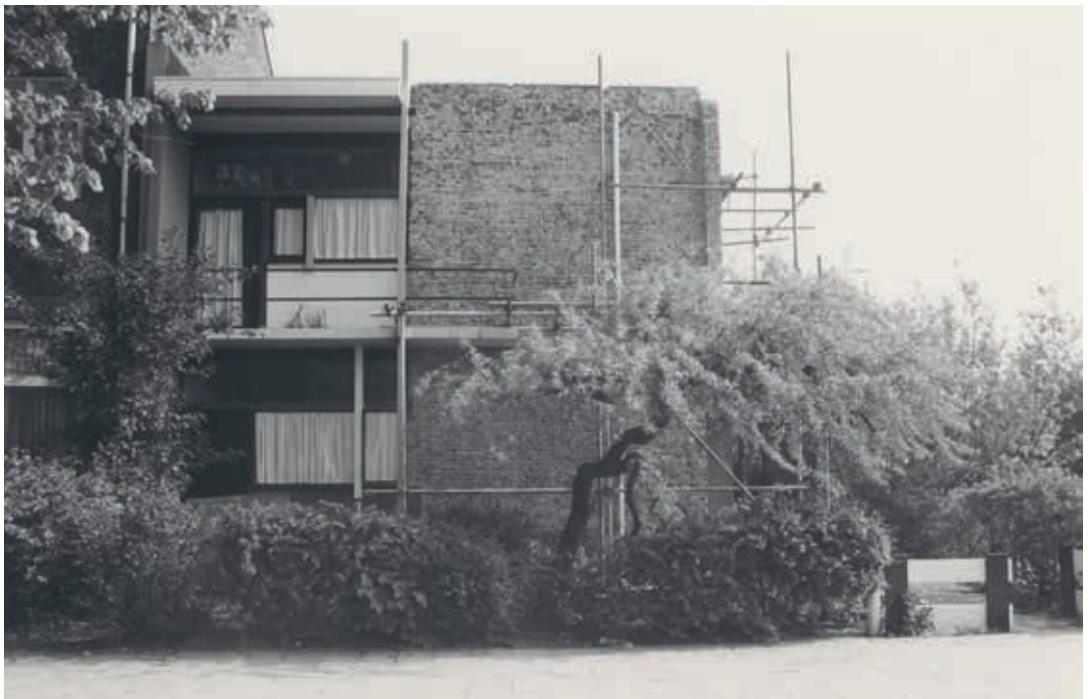
6. The bare brickwork of the wall on Prins Hendriklaan in 1979. On the wall below the window of Rietveld's former studio (bottom left) render is still visible (Bertus Mulder archive)

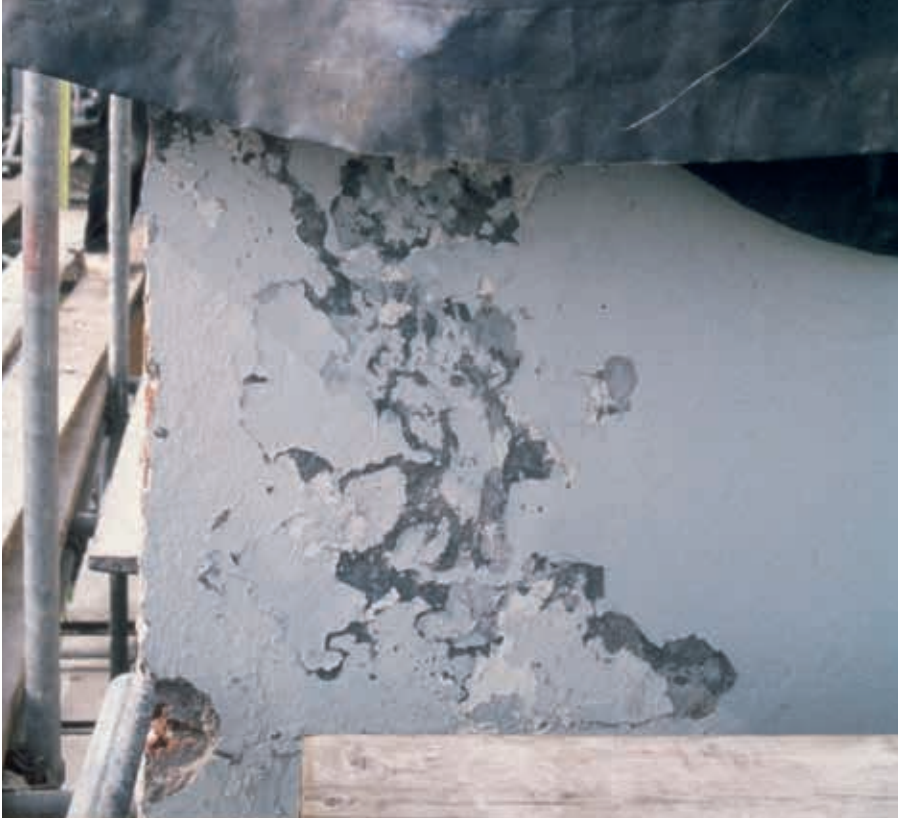
9. In several places, such as here on the chimney, Bertus Mulder discovered various remnants of render and finish coats (Bertus Mulder archive)

research on the house. Despite having been prepared to find that the earliest layers had been removed, he in fact encountered various finish coats and colours, for example on the chimney and the wall below the kitchen window (figs. 9 and 10). He analysed samples taken from these areas and took the results into account in his deliberations.²⁹ Afterwards he threw the samples away (fig. 11).³⁰ He painted the steel components of the house in yellow and black; frames, windows and doors were also painted black, with accents in yellow, white, red and blue. He then developed the colour composition of the plasterwork using five shades of grey plus white. In so doing he had, in his own words, reinstated the earlier colour contrast 'in the spirit of Rietveld'.³¹

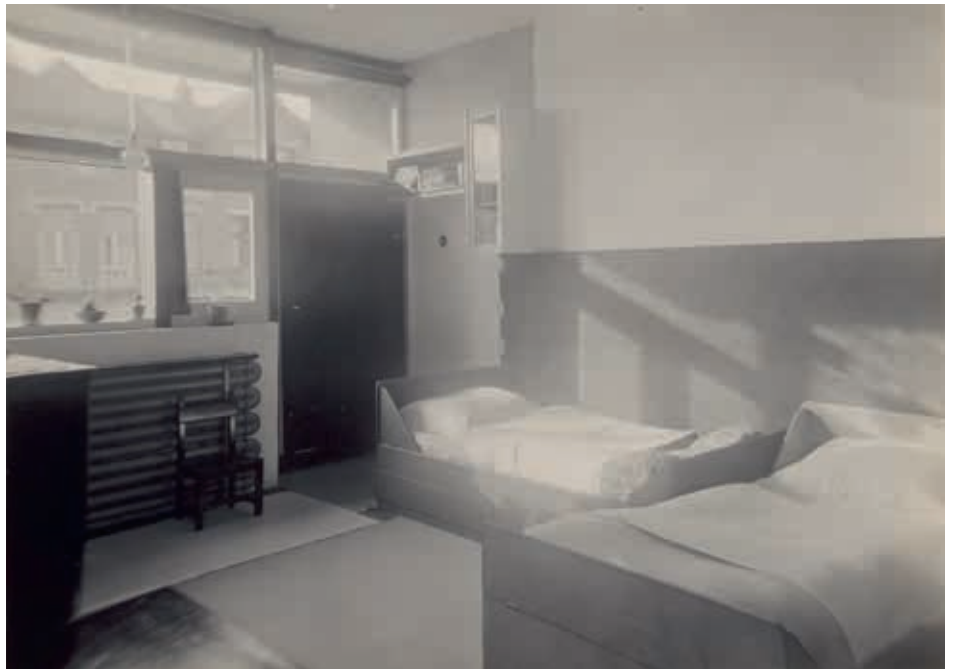
12. The bedroom of the Schröder daughters around 1925, with the beds in the night-time position. The grey of the vertical strip beside the door continues through onto the balcony wall (Rietveld Schröder Archive, CMU)

In 1986, while stripping back the walls on the upper floor of the house, Mulder discovered below a layer of white paint in what had been the daughters' bedroom, a different shade of grey from the one he had used in 1979 for the adjoining balcony. Because this wall was supposed to run from inside to outside in the same colour, as can be seen in historical photographs, he had the exterior of this wall repainted (figs. 12 and 13). This meant that he ended up redoing the entire composition of greys on the exterior.³² Mulder's aim was to create a balanced, harmonious and impeccable image with colours and surfaces that would restore the original spatial impression. In 1981 the Stichting Rietveld Schröder Huis had decided that the guiding principle for the restoration of the interior should be 'to return the house in an abstract manner to the situation of 1925-1930'.³³ Truus Schröder, too, believed that after her death the house should not be presented 'as if she had just left', but as a manifesto of a new architecture and a new way of living. Initially there was some resistance to this from RDMZ. Wim Denslagen argued that the future museum house would in that case ignore the history of Schröder's occupancy and of Rietveld's

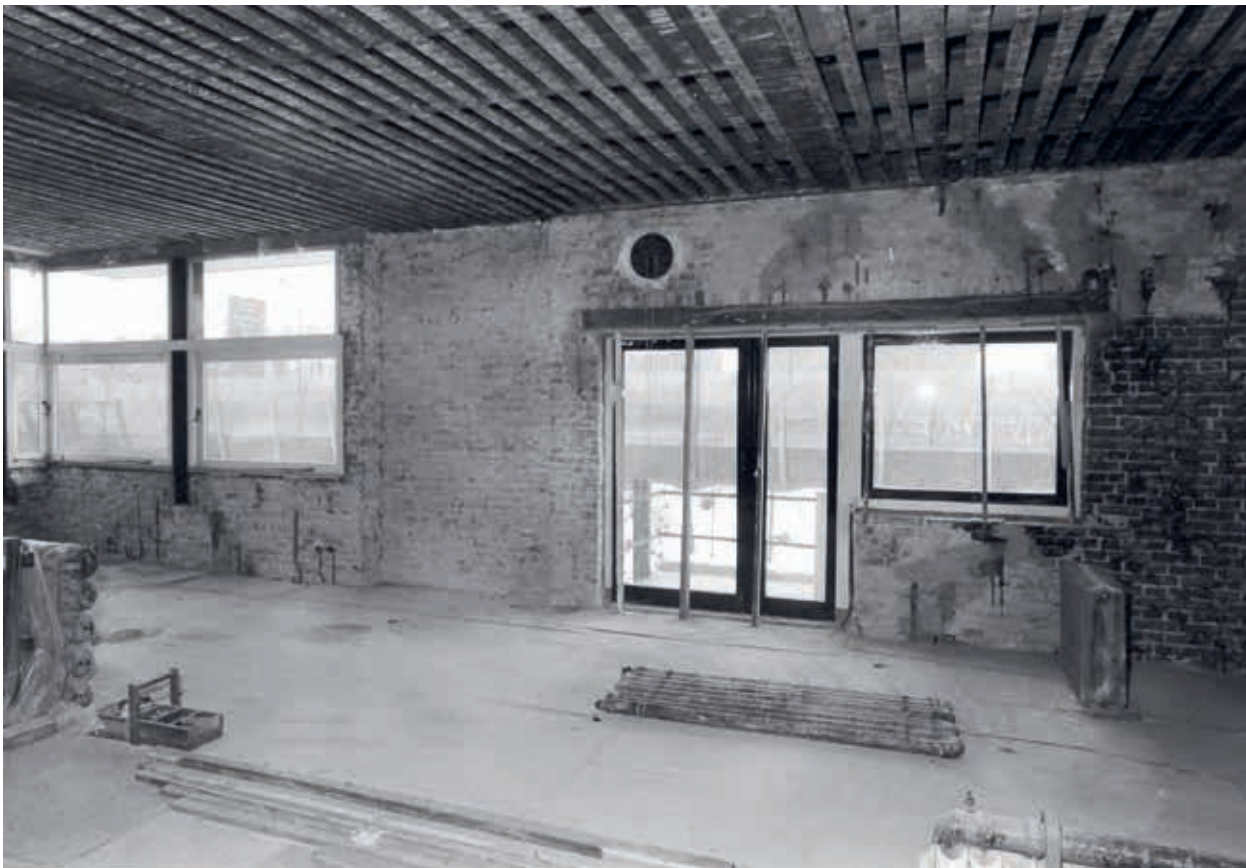
14. During the restoration of the upper floor of the Rietveld Schröder House in 1985-1986, Bertus Mulder completely stripped the walls and ceiling (Bertus Mulder archive)

Bertus Mulder had become so familiar with the house over the years that he knew exactly where to look for original traces and other clues of importance for the reconstruction. He set to work rigorously: the walls were chipped back to the bare bricks and the ceiling was demolished, after which the brickwork and plasterwork were repaired and renewed as with the exterior (fig. 14). Before allowing the old plaster to be carted away and destroyed, Mulder examined it with respect to colour and composition. The plasterer, H. van de Kant, prepared the new plaster using the correct composition and sanded the base coat 'with jute on a wooden board' in a circular motion in order to achieve the same grainy effect as under Rietveld.³⁷ Because the

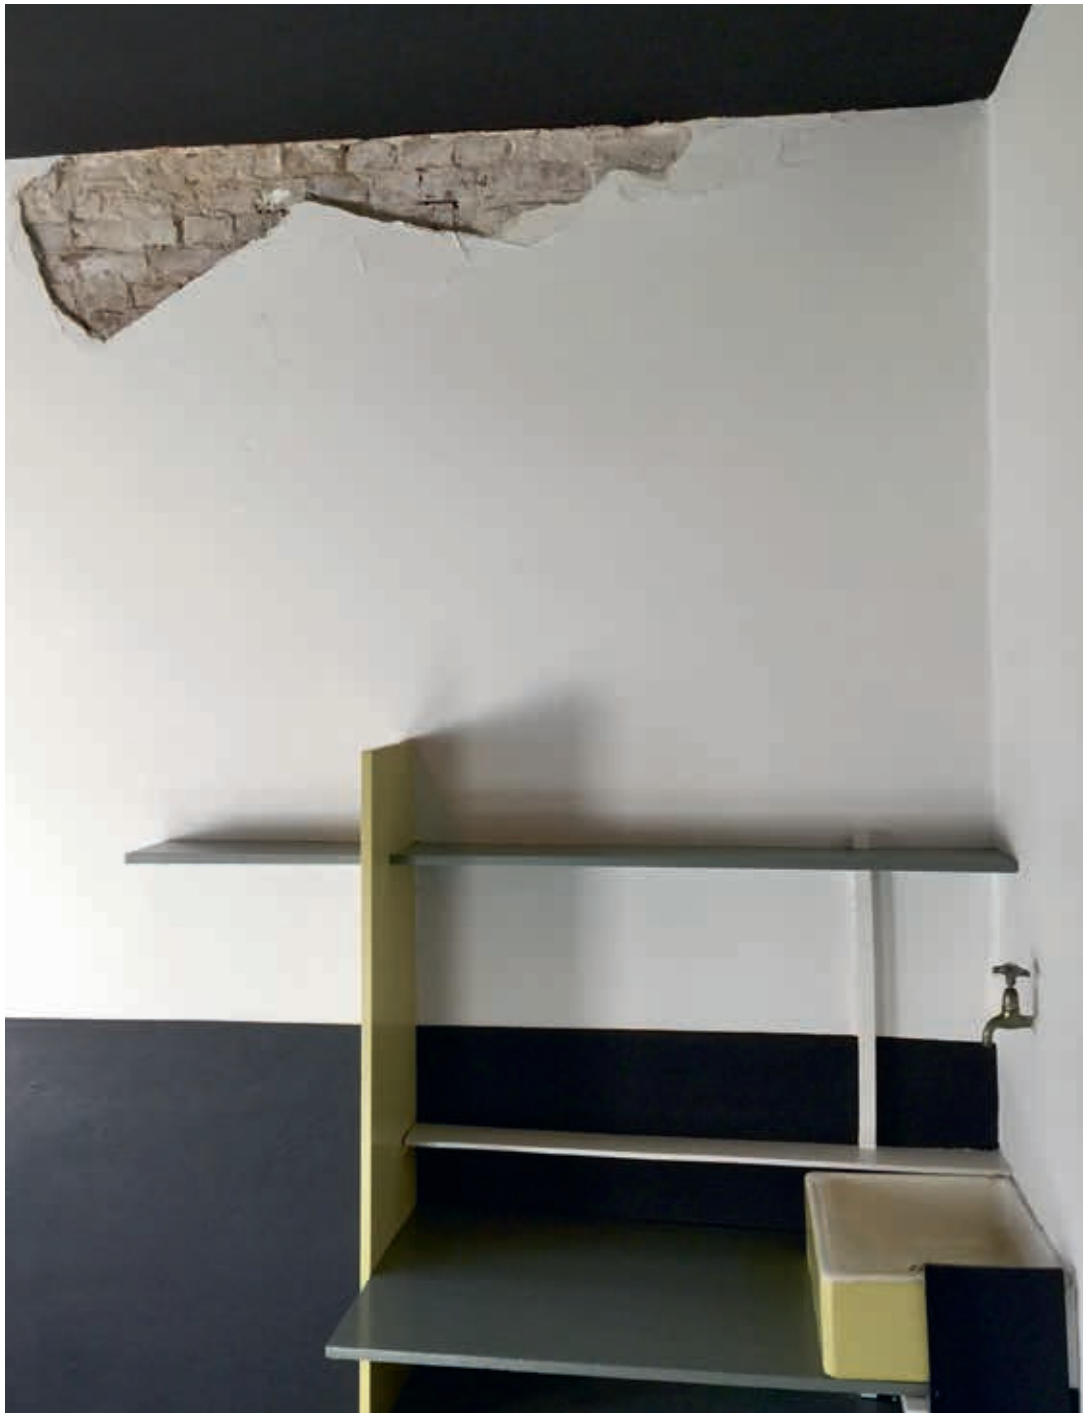
15. In October 2016 a piece of plaster came loose on the south wall of the study on the ground floor of the Rietveld Schröder House, photo Edgar Riessen (CMU)

repainted in the same colours that he encountered there. The ground floor was, in his eyes, of less importance for the architectural value.³⁹ In October 2016 a piece of plaster came loose from a wall in the study (fig. 15). This turned out to be a blessing in disguise because it provided an opportunity to have the plaster analysed by TU Delft and the TNO (Netherlands Organisation for Applied Scientific Research). TNO concluded that the sample could well be a remnant of the original plaster.⁴⁰

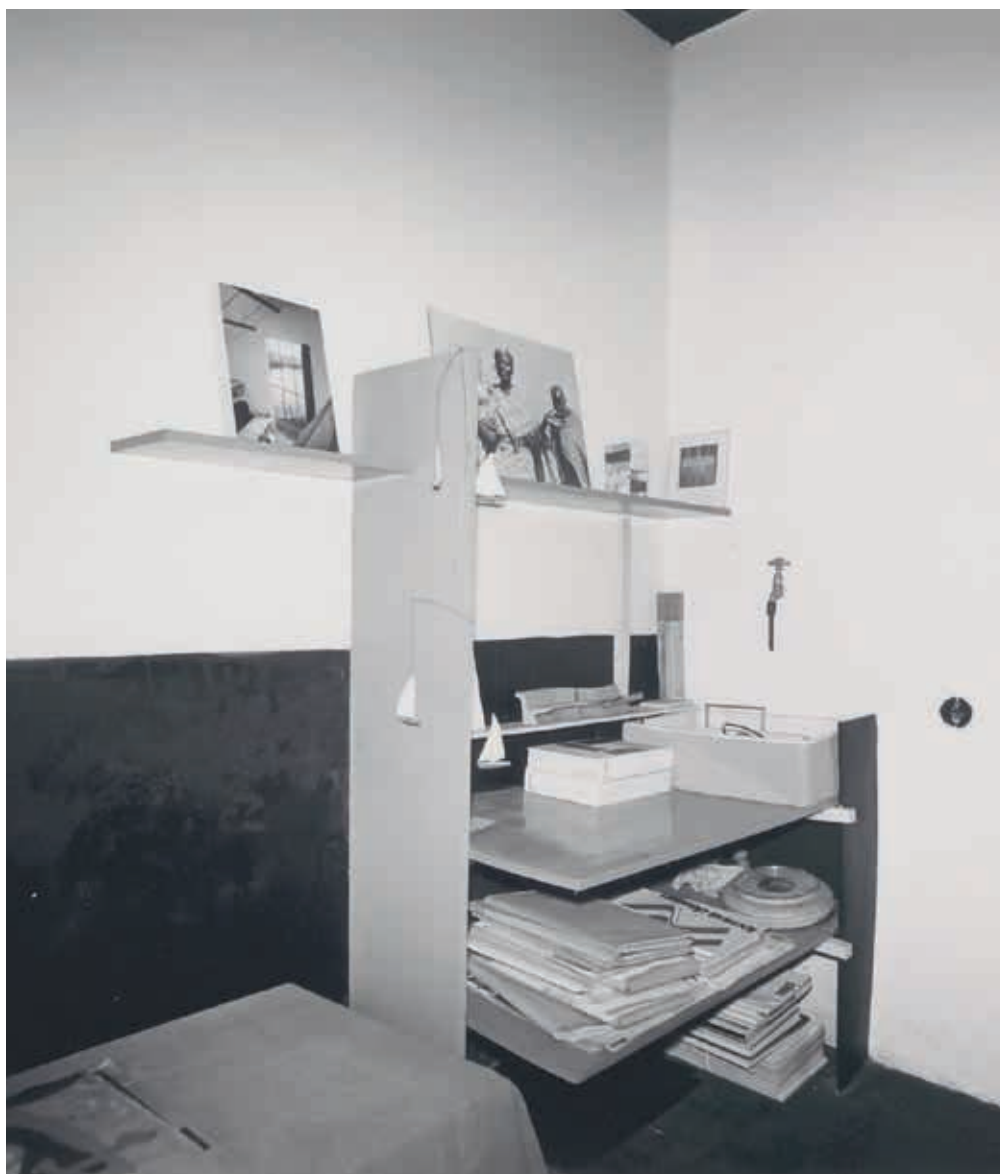
16. The south wall of the study on the ground floor of the Rietveld Schröder House, undated historical photo (Bertus Mulder archive)

reasonable to surmise the continued presence of some original plaster plus finish coats on both the exterior and the ground-floor interior (fig. 16). Accordingly, TNO and Stichting Restauratie Atelier Limburg (SRAL) conducted a limited follow-up investigation (fig. 17).⁴¹ The results confirmed the supposition: the Rietveld Schröder House still contains material remnants of the exterior and interior skin from the 'Rietveld period', be it highly concentrated in specific areas. SRAL was also able to state that parts of the ground floor had been repainted three times since the restoration, in colours that deviate from both the restoration period and the period(s) before that.⁴²

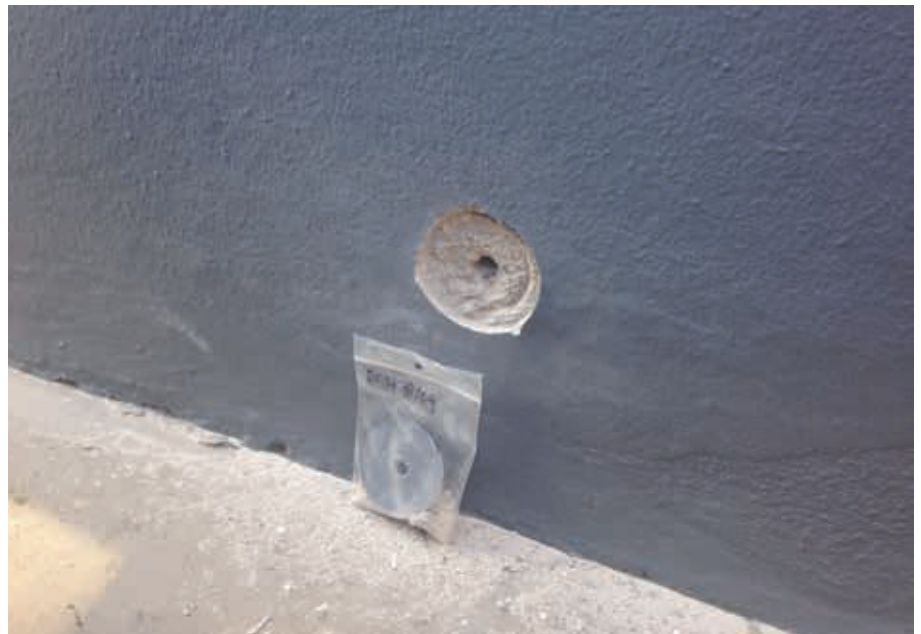
17. In 2018 TNO and Stichting Restauratie Atelier Limburg took samples from specific areas of the exterior and the interior of the Rietveld Schröder House. The photograph shows a sample from the balcony wall on the east elevation (photo author)
