'A SUBSTANTIAL WALL SET BETWEEN TWO SLENDER TOWERS'

THE ORIGINAL DESIGN OF THE WEST ELEVATION OF THE RIDDERZAAL

PAULA VAN DER HEIDEN EN
HEIN HUNDERTMARK

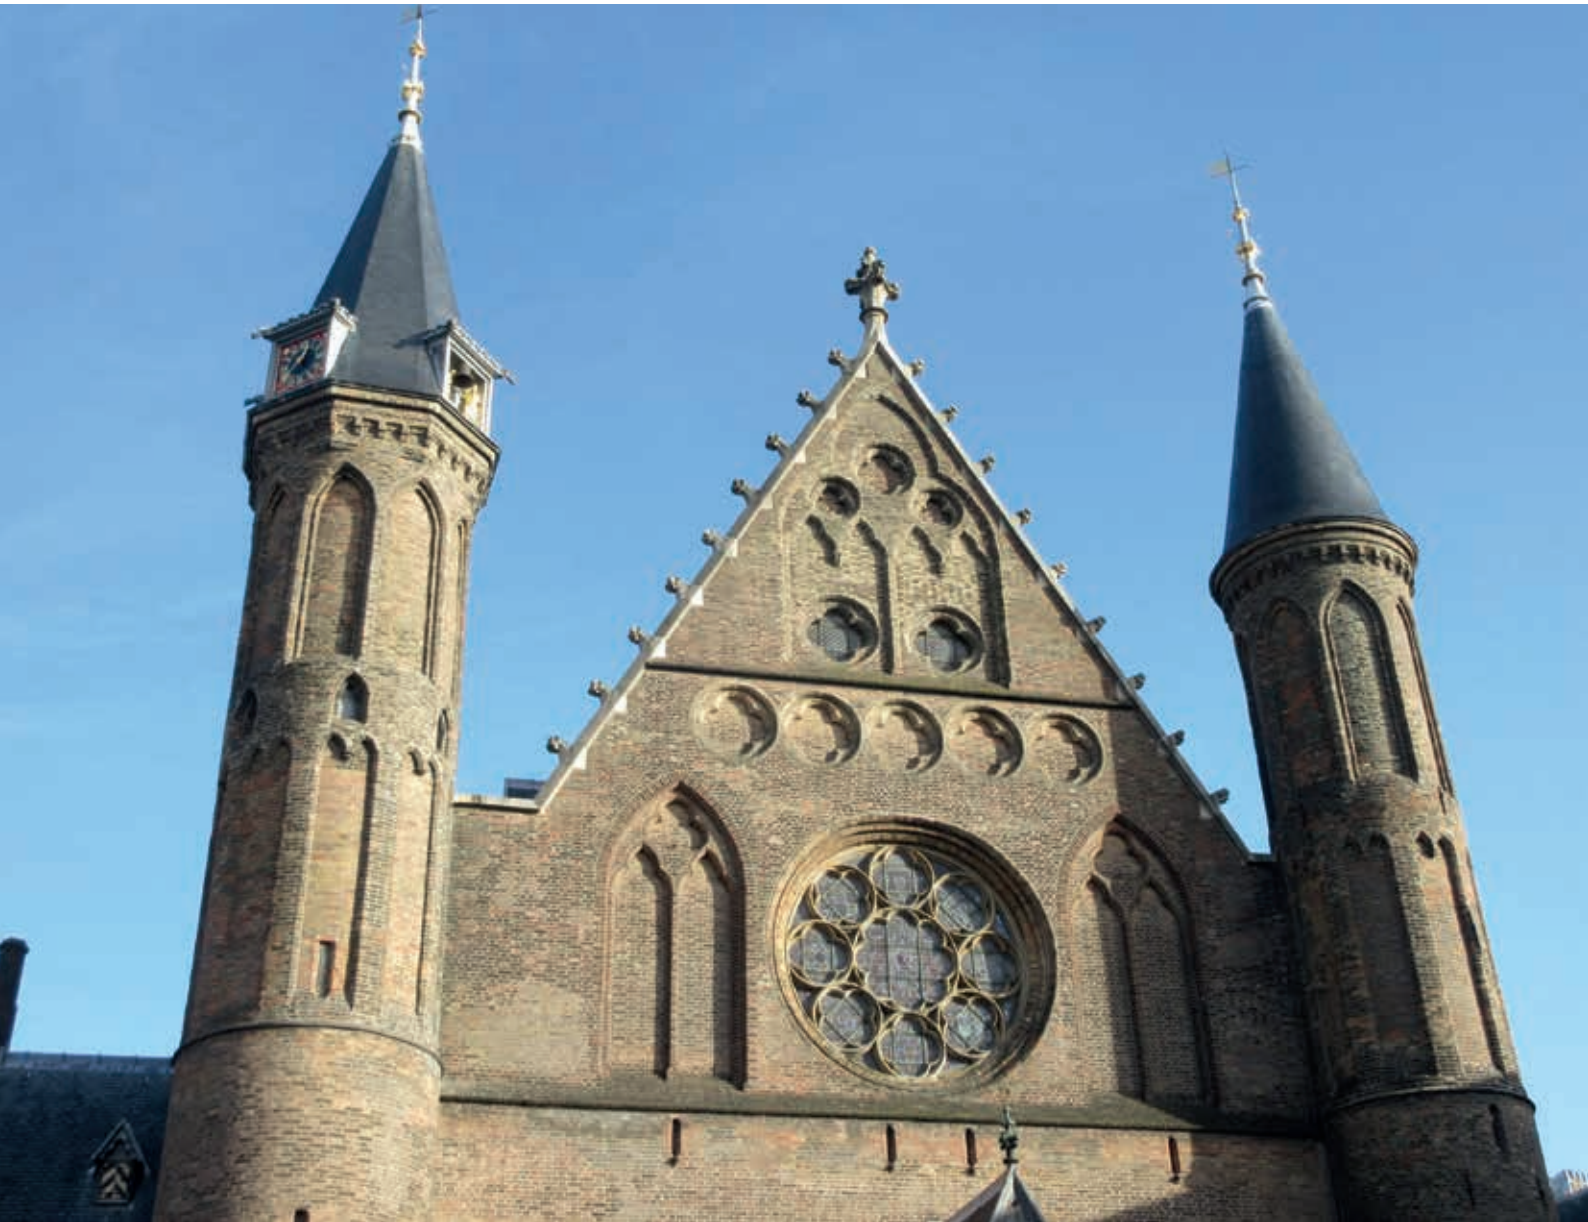
- ▲ 1. The front facade of the Great Hall (photo H. Hundertmark, 2020)
- ▶ 2. The Great Hall with the largely built-in west front. The gable shoulders are visible between gable and towers. The original side wings are visible left and right of the gable and towers, with the ridge line of the roof at right angles to the Great Hall. The left wing is taller than the right one and has been largely built-in by later additions. Pen and ink drawing, maker unknown, c. 1670 (The Hague City Archives)

The front facade of the Great Hall (Ridderzaal) is the icon of the Binnenhof (fig. 1). The facade appears with great regularity on the nation's television screens whenever political matters feature in the news broadcasts, thereby making it possibly the best-known facade in the country: a readily recognizable and also imposing image made up of a triangular gable between two distinctive towers or, as Arnold Ising put it in 1879, 'a substantial wall set between two slender towers'.¹

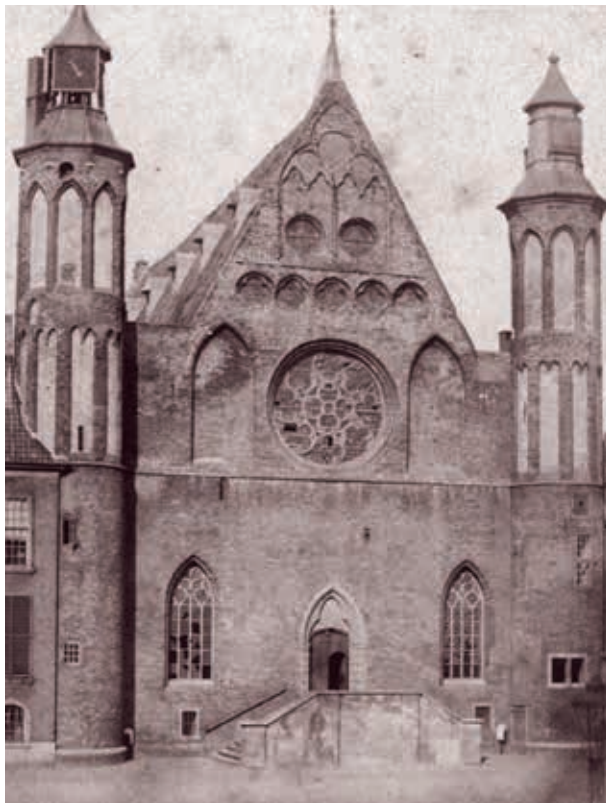
3A. The west front of the Great Hall in 1860, showing the tracery of lead-covered wood inserted in the two pointed-arch windows in 1814, and the rose window. The gable displays the original steep wall line that is aligned with the original roof construction. Only the gable shoulders have been raised (The Hague City Archives)

was raised, resulting in shoulder pieces that are visible in seventeenth-century paintings (fig. 2). When the roof was renewed, the masonry of the side elevations was raised by around five metres (from eleven to c. sixteen metres), which altered the roof line. Because of the shallower roof slope, the masonry of the front (and rear) facade needed to be adjusted to the new roof line. The new brickwork was rather crudely toothed into the existing masonry. Towards the underside of the gable the new brickwork increases in width resulting in considerably narrower shoulder pieces between gable and towers. The width of the shoulder piece at the southwest tower is practically zero. After this major intervention the west elevation made a rather battered impression that appears, on the evidence of photographs, to have persisted until the restoration of the facade in 1877-1880 (fig. 3).

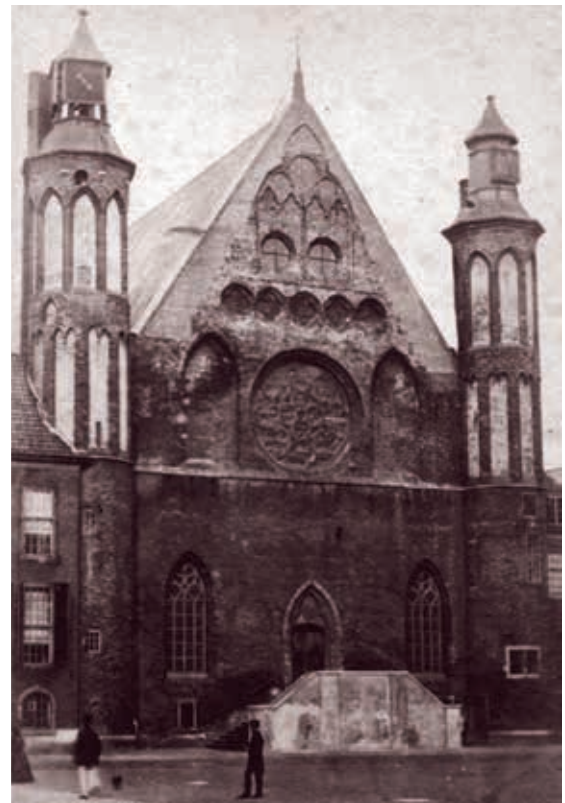
3B. The gable in 1865, following the replacement of the 1295 timber roof structure with a cast iron structure by government architect W.N. Rose in 1861. Because this new roof structure had a different pitch, the gable was adjusted by means of new masonry in a different brick that was fairly crudely toothed into the original medieval brickwork (The Hague City Archives)

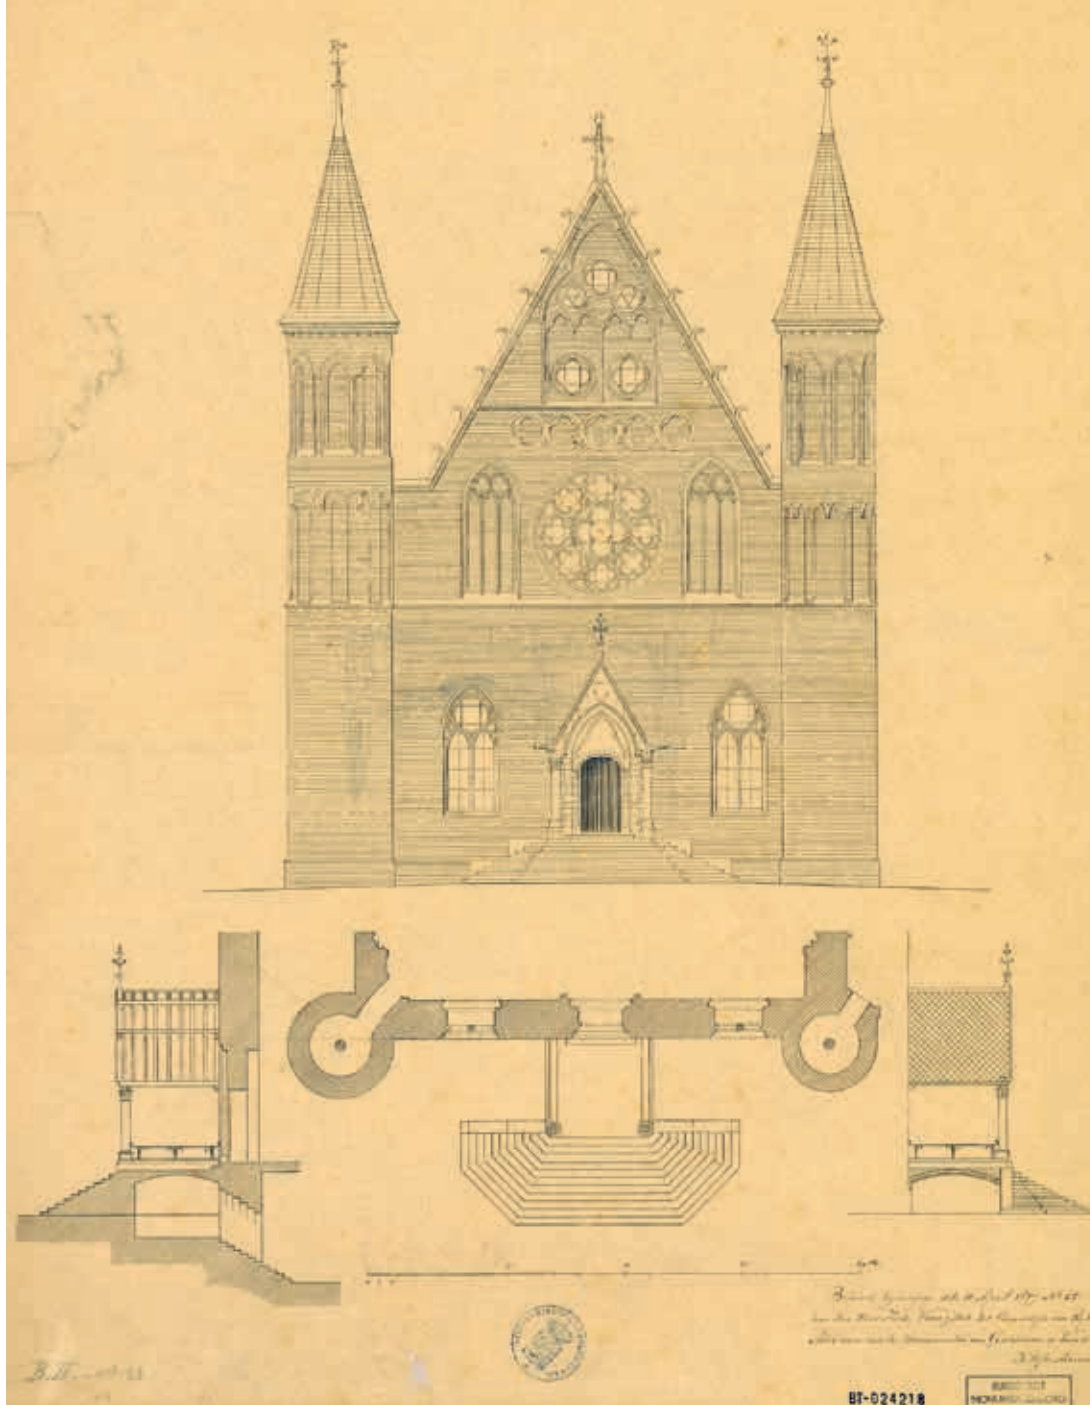
4. Drawing of the restoration proposal for the Great Hall west front from 1877. The towers acquire new terminals and the entrance an entrance porch with a flight of steps. The rose window and two pointed-arch windows acquire stone tracery as do the pointed-arch niches left and right of the rose window (Cultural Heritage Agency)

A drawing from 1877 depicts the planned restoration works for the west elevation in broad outline (fig. 4). The idea was to enhance the medieval appearance by replacing the 1861 brickwork using bricks of medieval dimensions and to finish the gable with a moulding with crockets, crowned by a double finial. However, owing to the shallower roof slope introduced in 1861 the gable was more massive than its medieval predecessor, making it impossible to reinstate the shoulder pieces at the original height.

The five round niches at the top of the gable were to be decorated with trefoils and quatrefoils inset with leaded lights. As indicated in the drawing, stone tracery, which had never been there originally, was added to the pointed arch niches. Likewise, the rose window acquired its present stone tracery at this time. In the lower part of the facade, new tracery was introduced into the pointed arch windows and the original Douai stone surround of the entrance was completely renewed and embellished with a portico with steps leading up to the entrance (fig. 5).

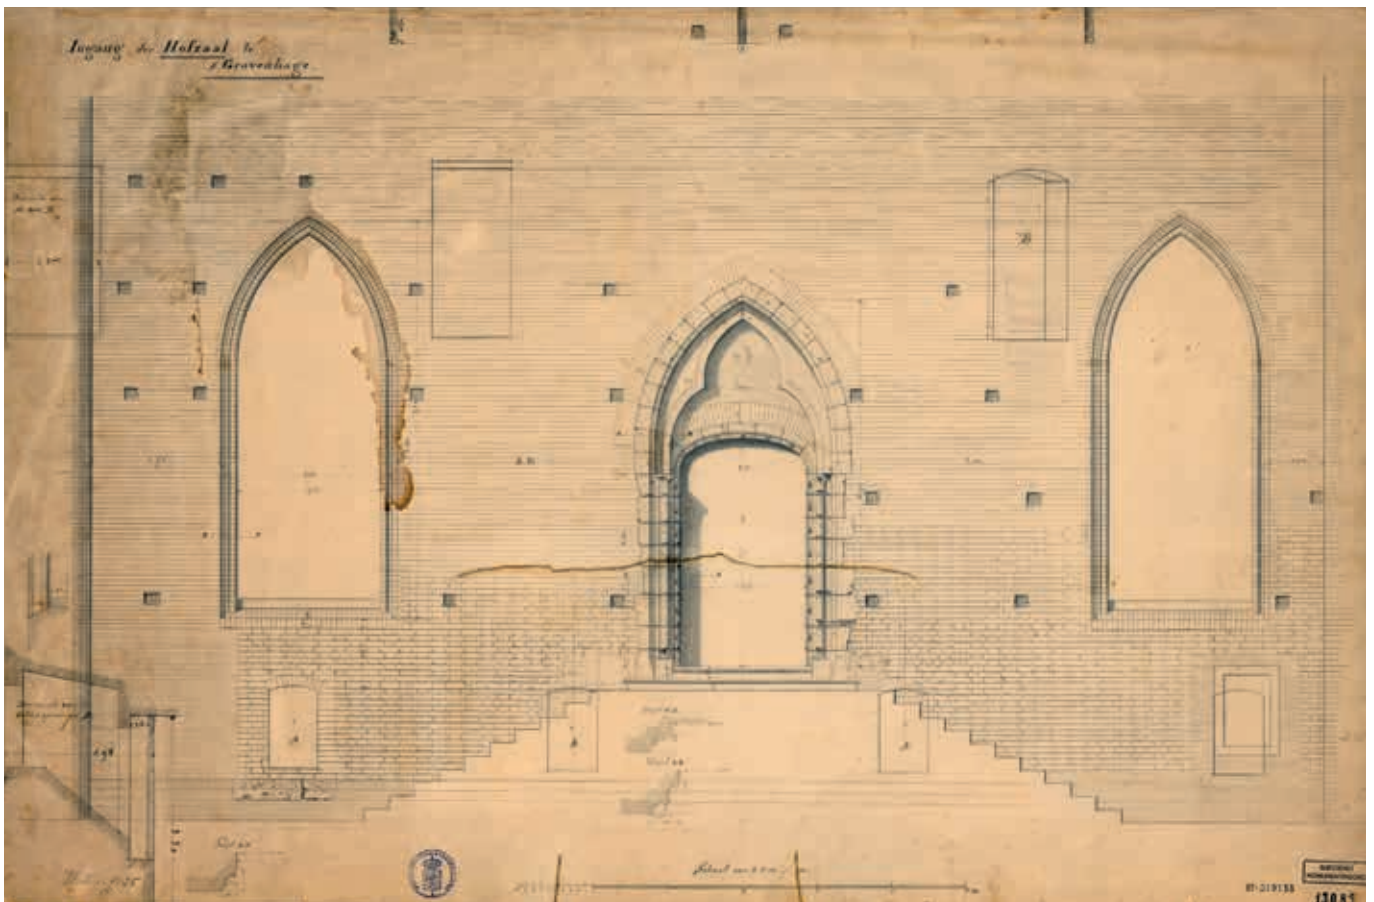
5. Documentation drawing of the entrance area of the west front of the Great Hall from c. 1875. It shows the 1295 entrance in Douai stone, flanked by pointed-arch windows. These were designed in 1814 by the architect for government buildings, A. Noordendorp, after Louis Napoleon had ordered the removal of previous additions to the west front. The profiled reveals of these windows are in a smaller brick than the original Flemish bond brickwork (Cultural Heritage Agency)

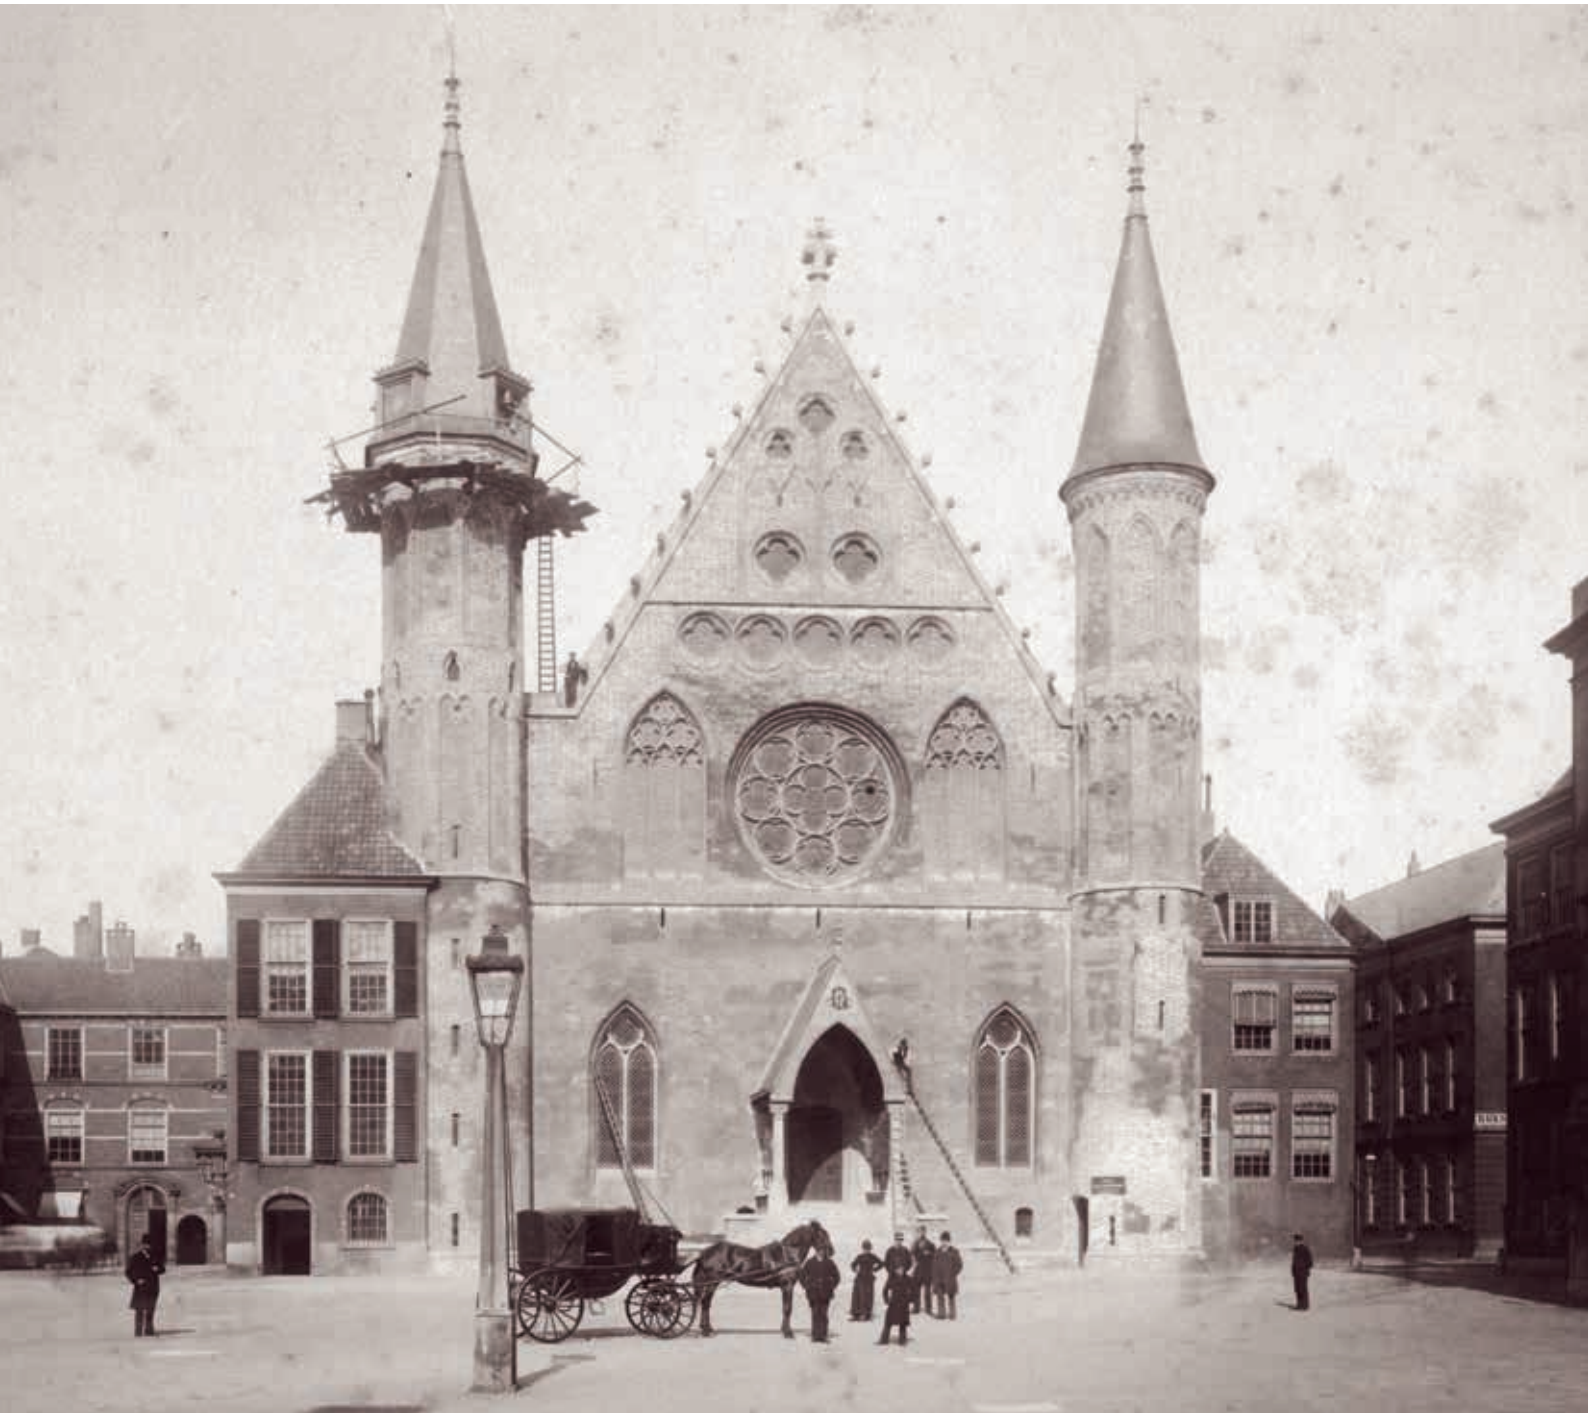
6. The west front of the Knights' Hall during final restoration works in 1880. The reinstated 'medieval' gable emulates the roof line of the 1861 cast iron roof structure. As a result the gable has a larger building mass and the gable wall line a shallower pitch than the original medieval gable (The Hague City Archives)

Lastly, the towers were restored, involving the replacement of the sixteenth-century terminals (fig. 6). The new spires are identical in the design drawing, but for some reason differed from one another in execution: the northwest tower retained its octagonal structure with eight-sided spire, while the southwest tower was given a round spire.¹⁴

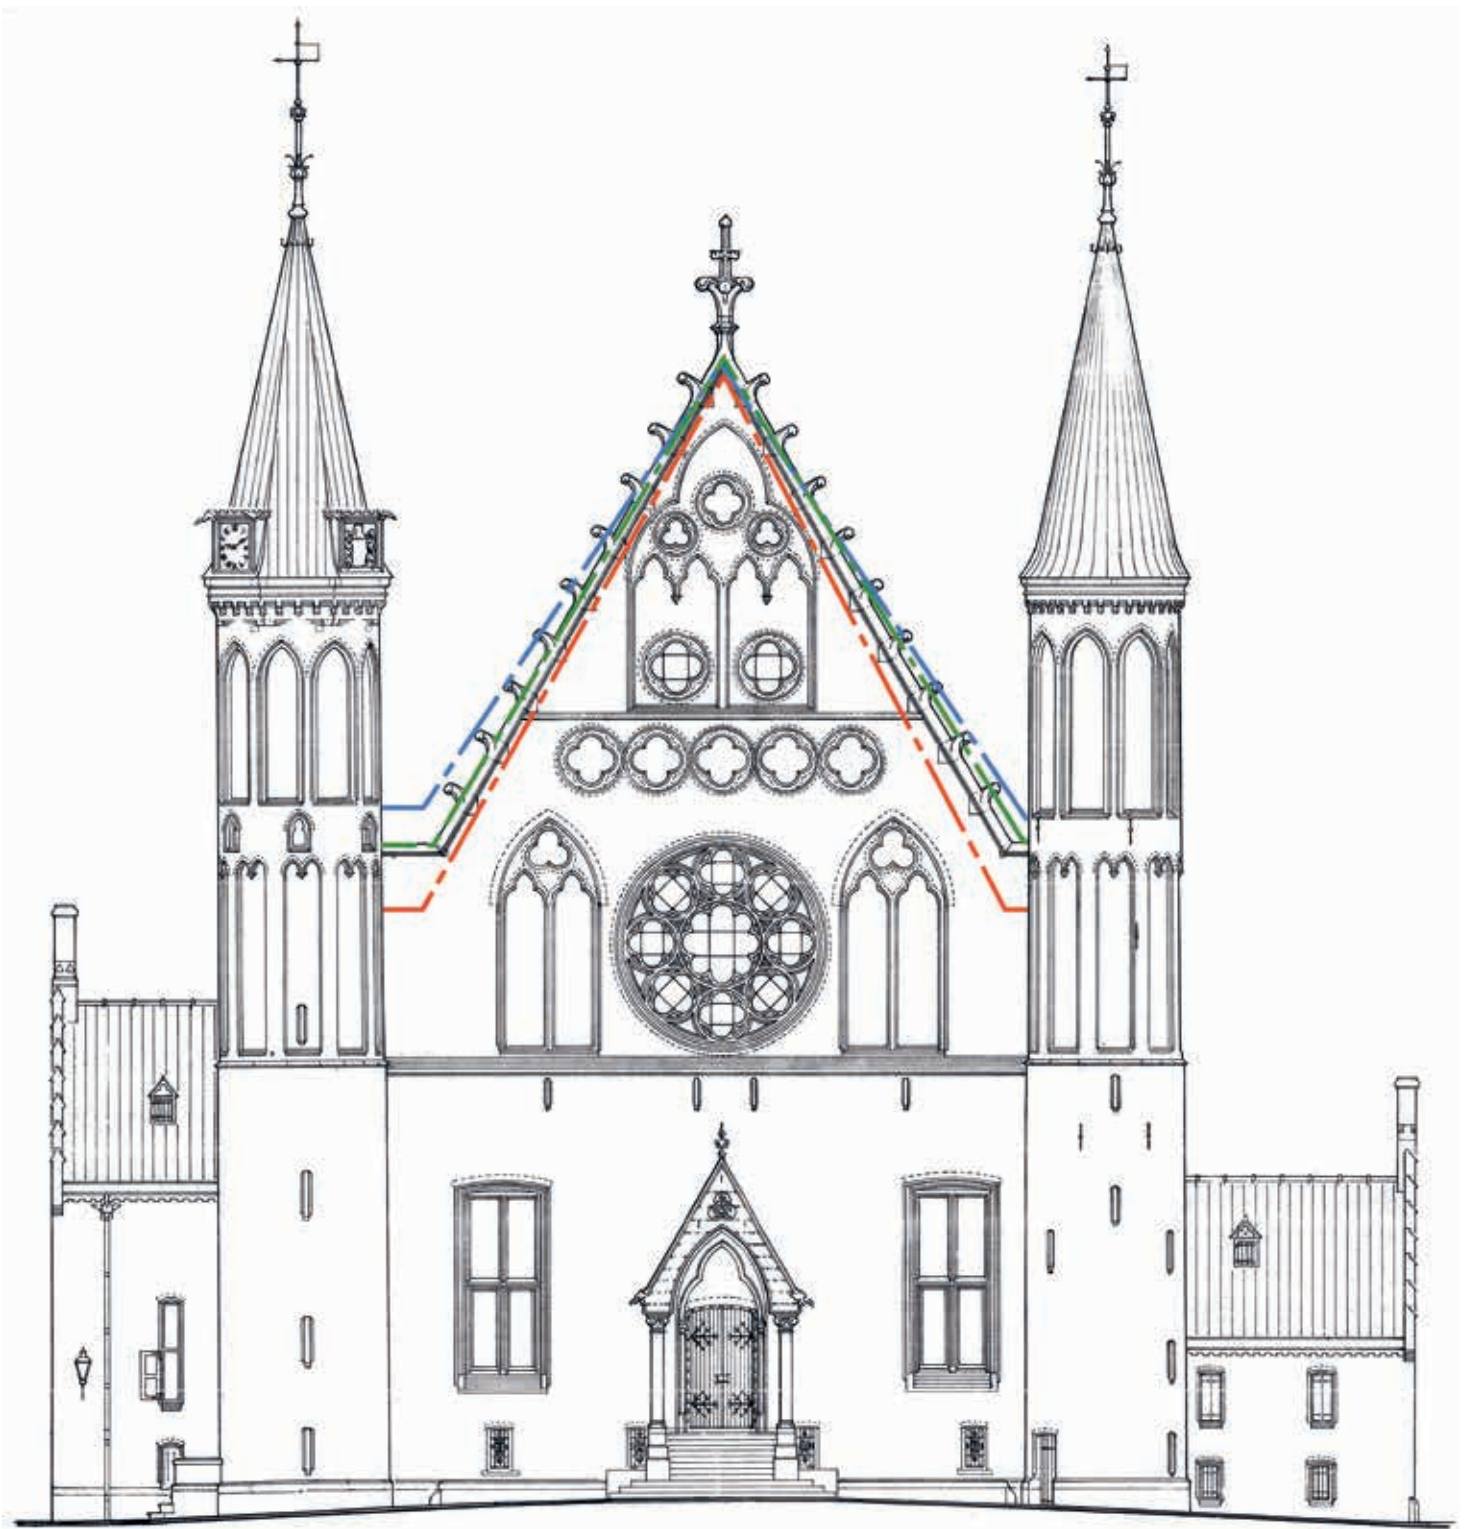
7. West front of the Great Hall. Coloured dotted lines show the three different gable wall lines that preceded today's (solid black) line, which dates from 1900 (drawing H. Hundertmark, 2021)

der piece to be retained. On the right side the gable line was shifted slightly inwards at the bottom, generating a 'proper' shoulder piece to counterbalance the left shoulder piece.¹⁵ All in all, the current gable is more massive than the original medieval facade in which the gable end and roof line were closer together and the original shoulders sat at a significantly lower level (fig. 7).

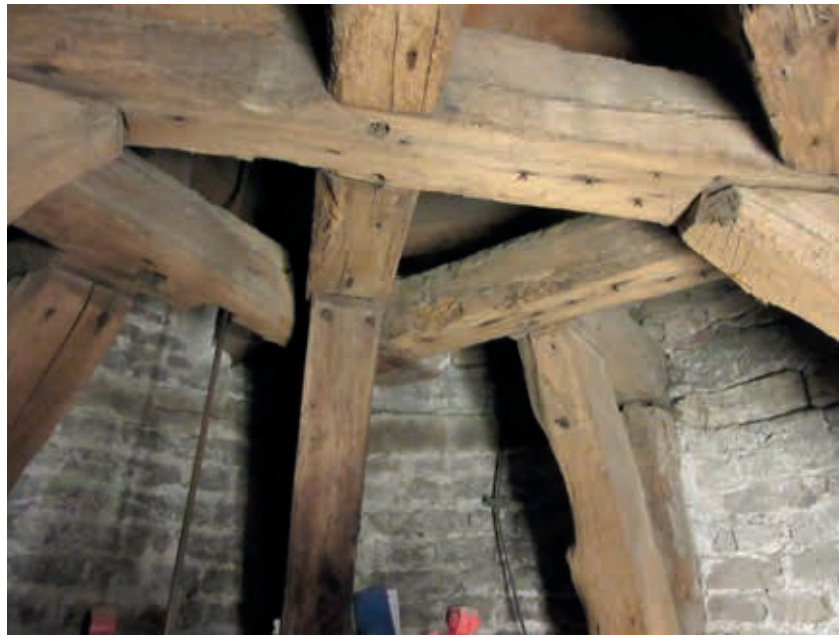
8. Upper horizontal framework of the entablature in the northwest tower of the Great Hall. Scribed assembly marks are visible on the beams. The oak entablature was constructed in 1295 and originally supported a spire (photo H. Hundertmark, 2021)

6 years.²⁴ These dates for the brace timber gave rise to the idea that some timbers may have been reused and that the wall posts are in fact recycled rafters from the monumental roof construction of the Great Hall.²⁵ However, this is contradicted by the documented assembly marks on these members, consisting of scribed marks, which occur from the end of the thirteenth century up until the transition to gouged assembly marks in the sixteenth century (fig. 8).²⁶

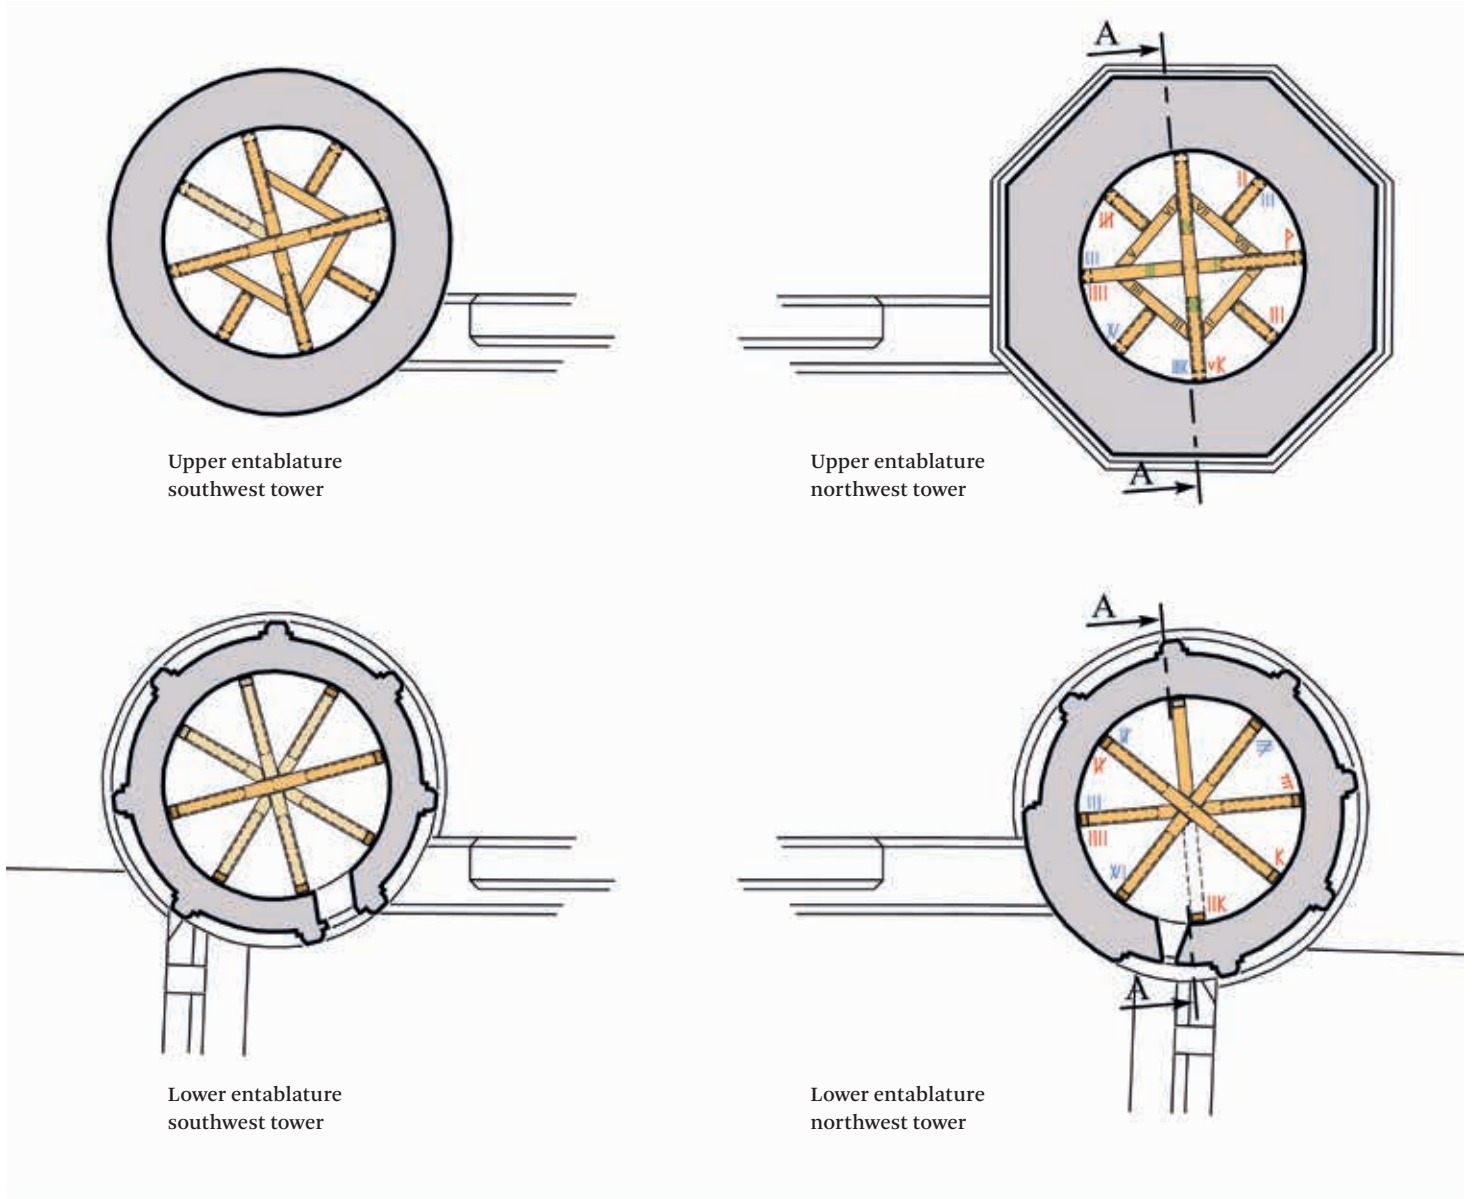
Upper entablature southwest tower

Upper entablature northwest tower

Lower entablature southwest tower

Lower entablature northwest tower

9. Plans of the upper section of the southwest and northwest towers of the Great Hall with the upper and lower horizontal framework of the entablature. In colour, the different assembly mark sets and types of wood (drawing H. Hundertmark, 2021)

The entablature in the northwest tower carries two sets of assembly marks. One set is scribed on the wall posts and corresponding corner braces and beams of the framework. A second continuous set of scribed assembly marks is found only on the horizontal beams of the upper framework. Interestingly, the continuous wall posts also carry a slightly different set of marks at the level of the lower framework. These also appear on the corresponding corner braces and beams of the framework, making it possible to distinguish the woodwork in the lower framework from that in the upper framework. For example, a post with corresponding beam in the upper framework is marked with vK and in the lower framework with IIIK, or in the upper with III and in the lower with K. So instead of a continuous series of assembly marks or assembly marks with directional marks there are marks of 'corner brace sets' with the unusual distinction between upper and lower as in roof trusses, or pairs of rafters with a distinction between left and right. The corner braces with corresponding beam and post also have different assembly marks to distinguish between the under- and upper side of the corner brace, owing to the fact that the corner braces are tenoned and cambered – rather than nailed – on the underside as well. On the post marked vK, the soffit of the corner brace and post

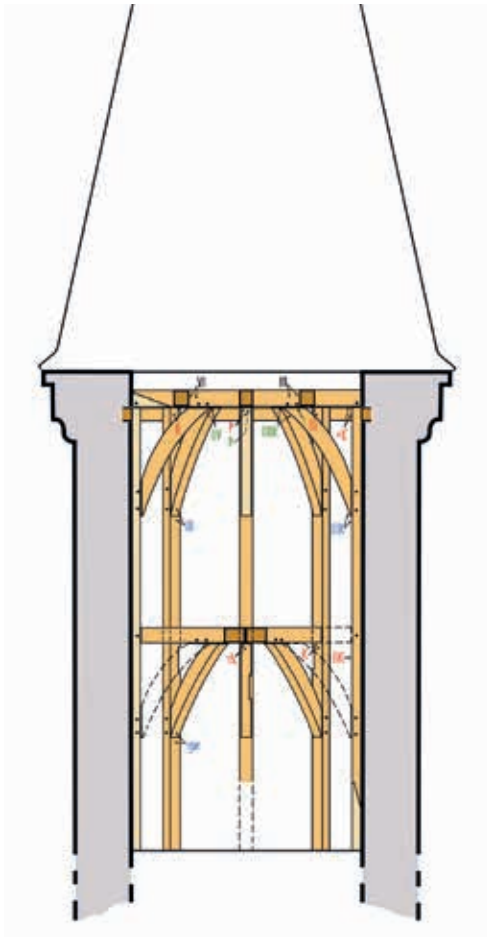
- vK Scribed assembly mark on upper side of the post and horizontal beam
- IIIK Scribed assembly mark on post and soffit of the corner brace
- IIK Scribed assembly mark on horizontal beam and upper side of the corner brace
- VI Scribed assembly mark on one side of the horizontal beam and shore

10. Vertical cross-section of the top part of the northwest tower of the Great Hall plus a cross-section of the entablature. In colour, the different sets of assembly marks and types of wood. The oak is the original wood used in 1295, while the pinewood indicates restoration work (drawing H. Hundertmark, 2021)

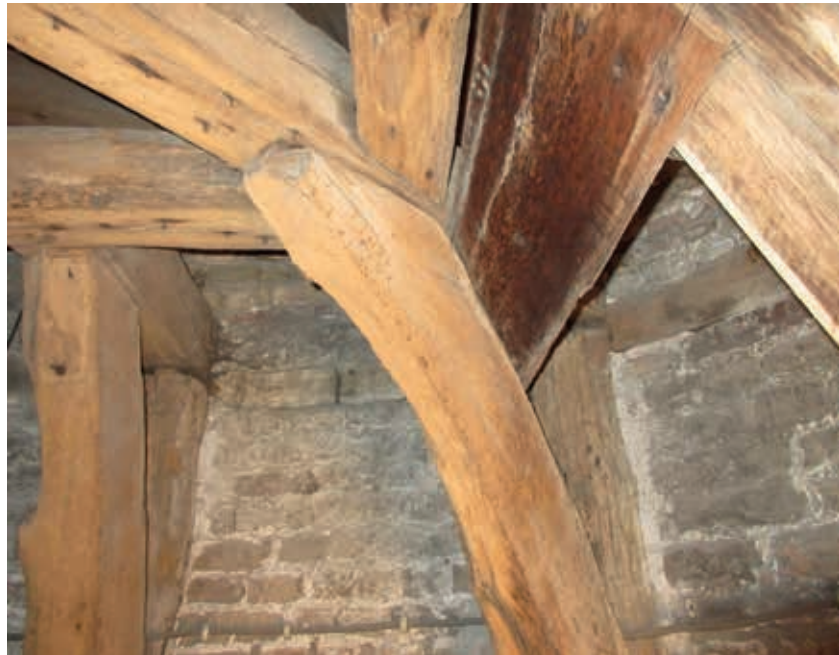
11. Detail of the upper horizontal framework of the entablature in the northwest tower of the Great Hall. The beams in this framework are imposed and notched into a circular wall plate, which has the same rounding as the outer brickwork of the round tower (photo H. Hundertmark, 2021)

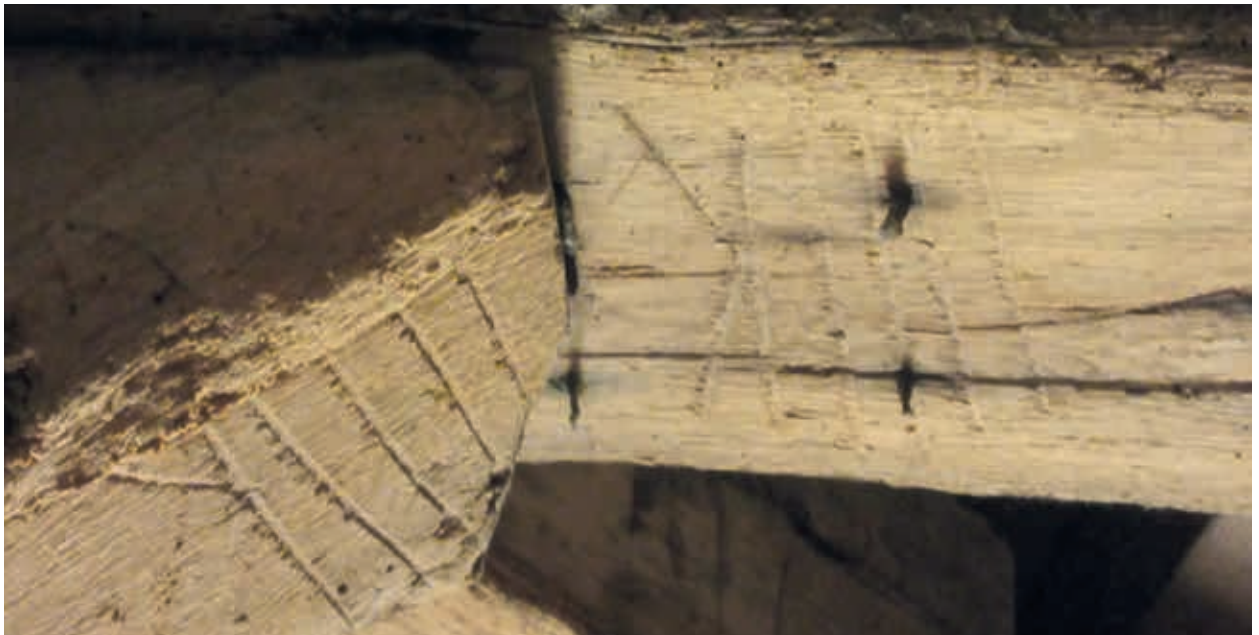
12. Detail of the oak entablature in the northwest tower of the Great Hall. The assembly mark IIIIK has been scribed on the upper side of the corner brace and on the soffit of the beam in the upper horizontal framework (photo H. Hundertmark, 2021)

bear the mark IIIK, while the upper side of the corner brace and beam of the horizontal framework is marked IIIIK (fig. 12). In the lower framework the soffits of the corner braces also display a set of assembly marks. Unfortunately it was not possible to determine whether the upper sides of these corner braces were also marked.
